STOCKTON LIFT UP SUPPORT ARM CODE No 02056 / 02056SL.

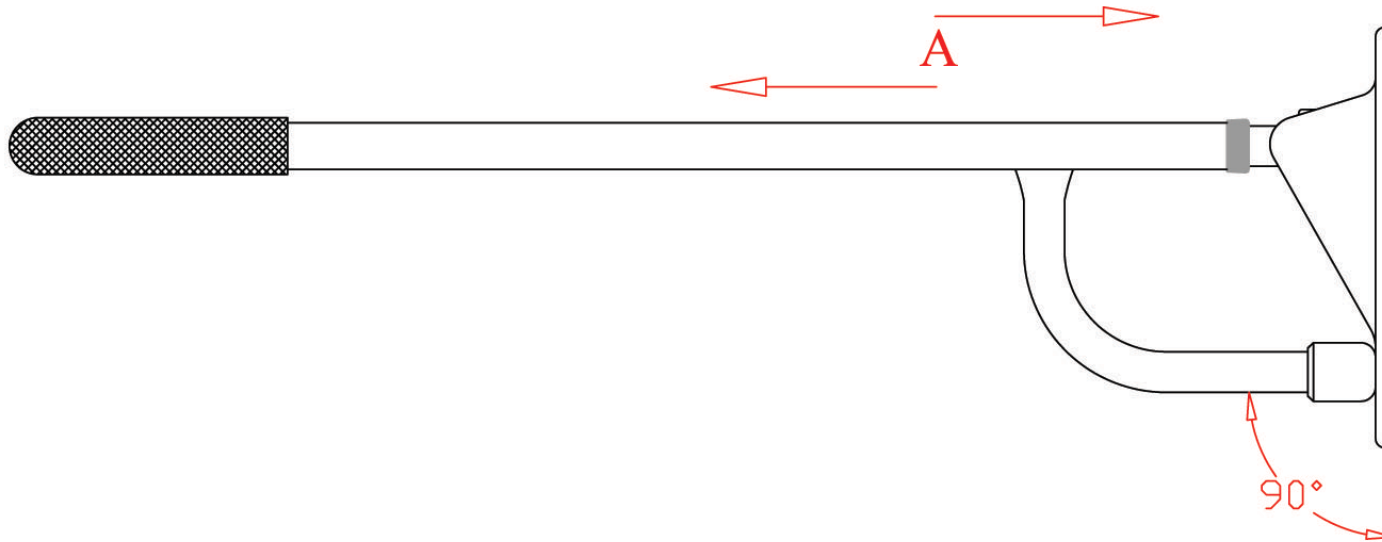
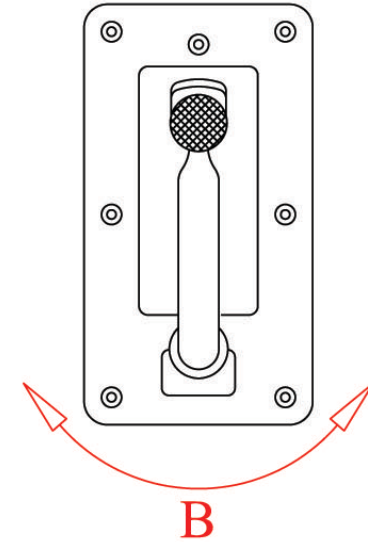
If There Is Any Movement In The Direction Of Arrows
"A" Or "B" Use The Following Procedure To
Re-Tighten.

Failure to re-tighten may result in personal injury!

- 1} Remove the wall bracket from wall.
- 2} Slacken bolt indicated "C" at rear of bracket.
- 3} Adjust the rail so that it is aligned at 90° to the wall.
- 4} Re-tighten bolt fully.

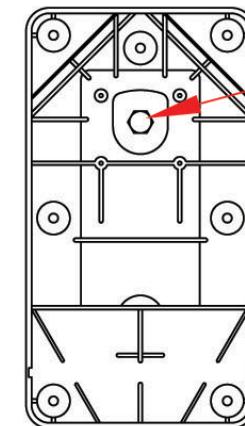
C
MUST BE
FULLY
TIGHT.
